Assessment of Dam Safety of Coal Combustion Surface Impoundments

Indianapolis Power & Light Company

Petersburg Generating Station

Draft Report

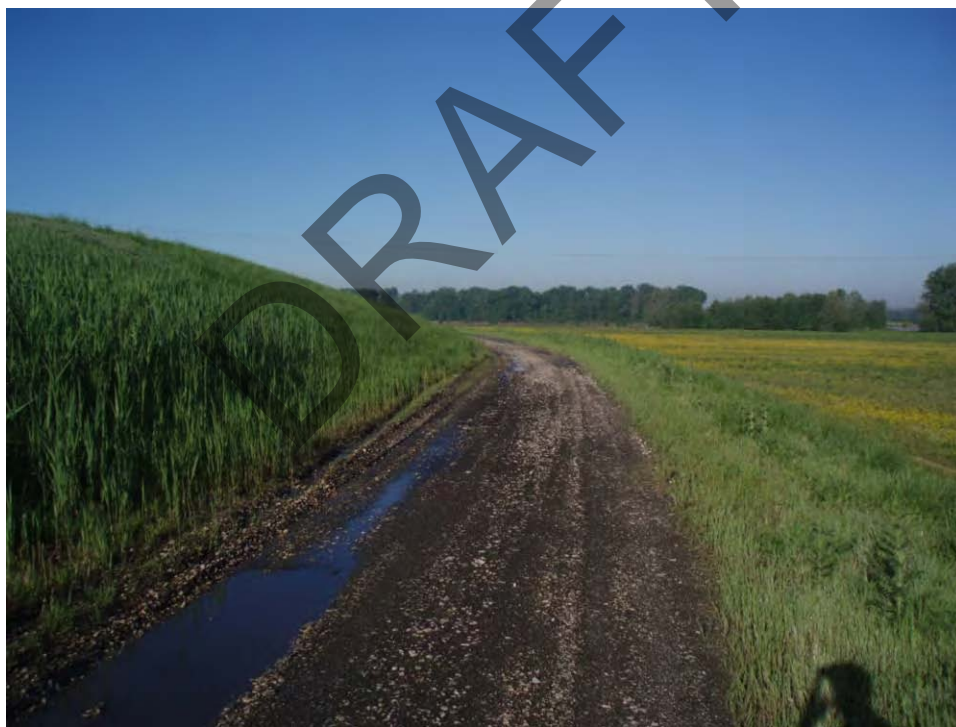
108. Pond C – West embankment bench, looking southwest.

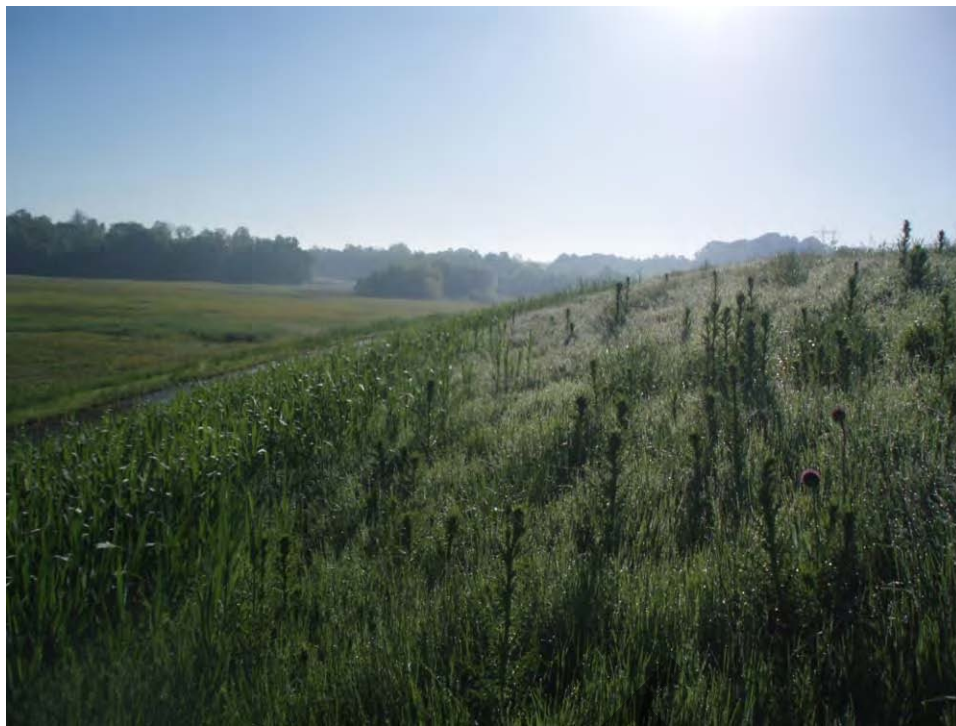
109. Pond C – West embankment upper exterior slope, looking northeast.

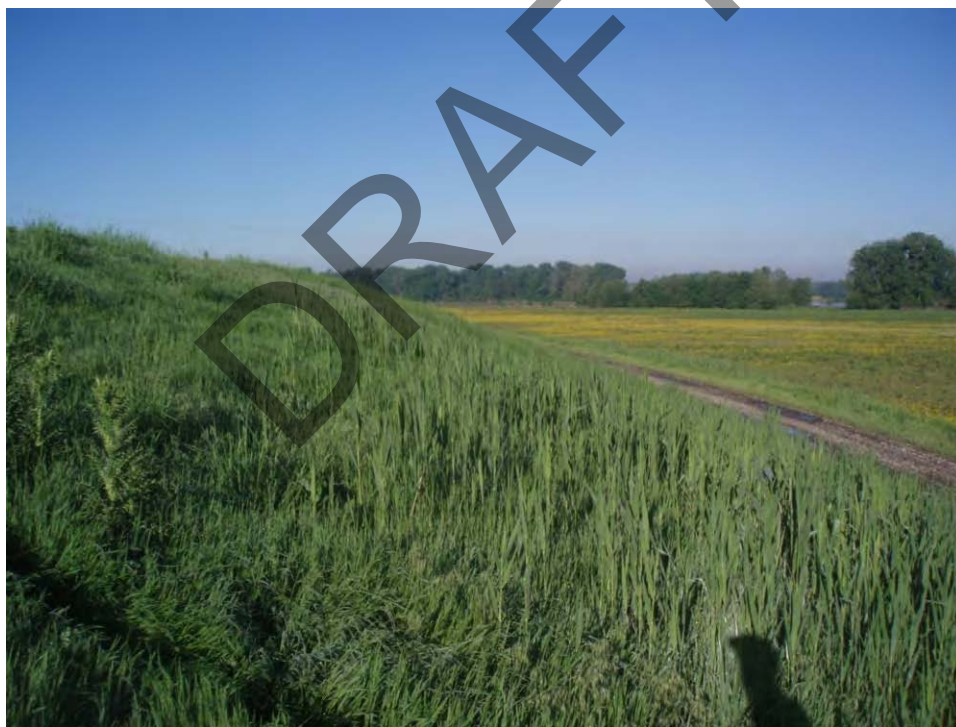
110. Pond C – West embankment upper exterior slope, looking southwest.

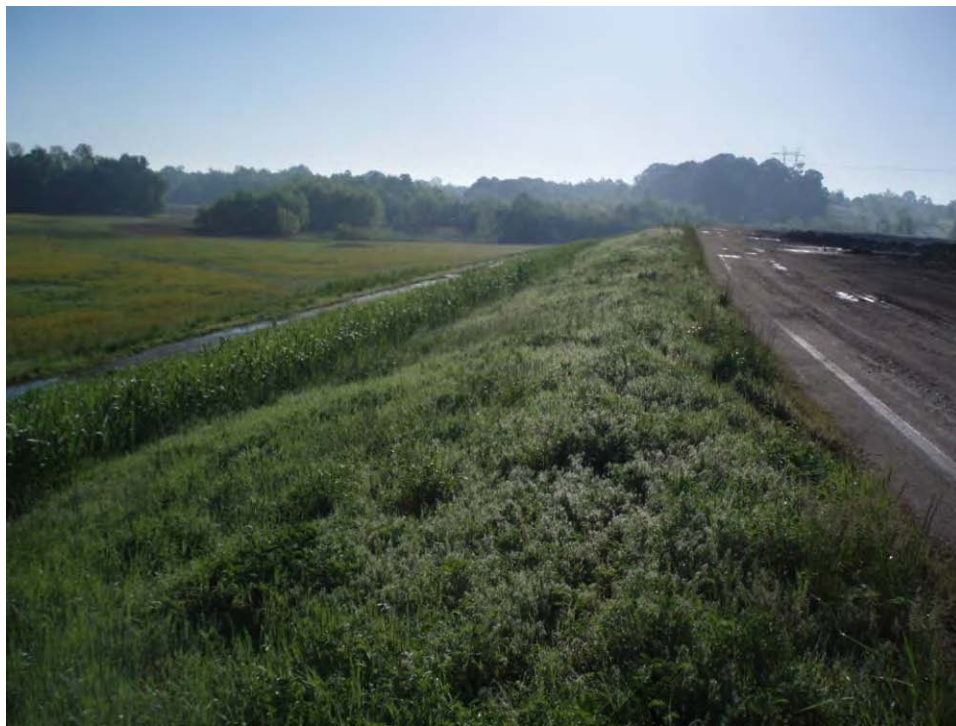
111. Pond C - West embankment crest, looking east.

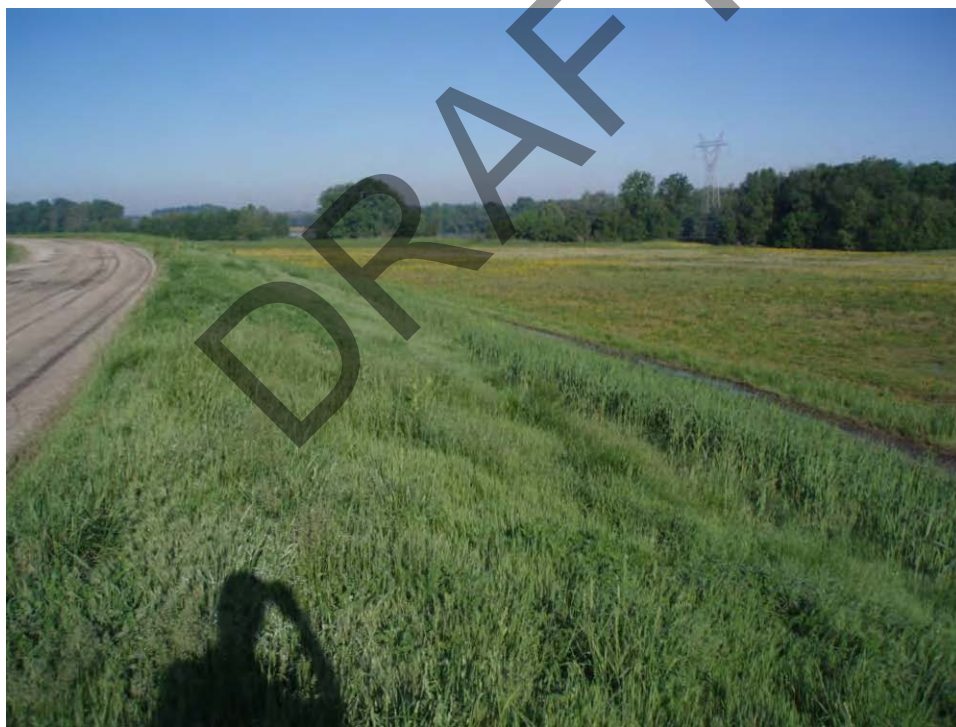
112. Pond C - West embankment crest, looking west.

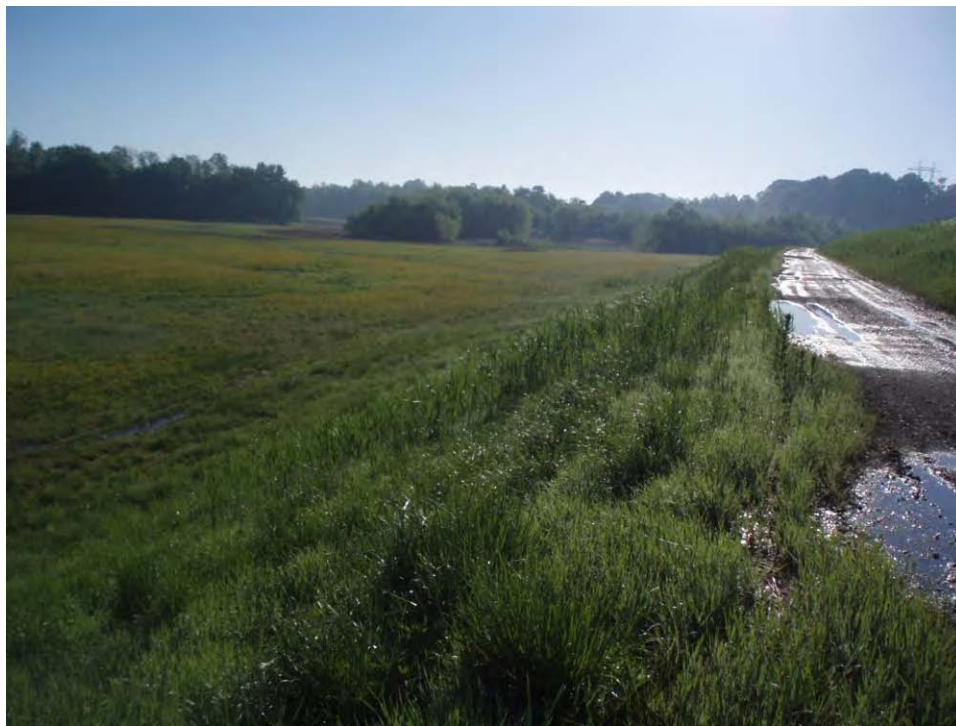
113. Pond C - West embankment bench, looking east.

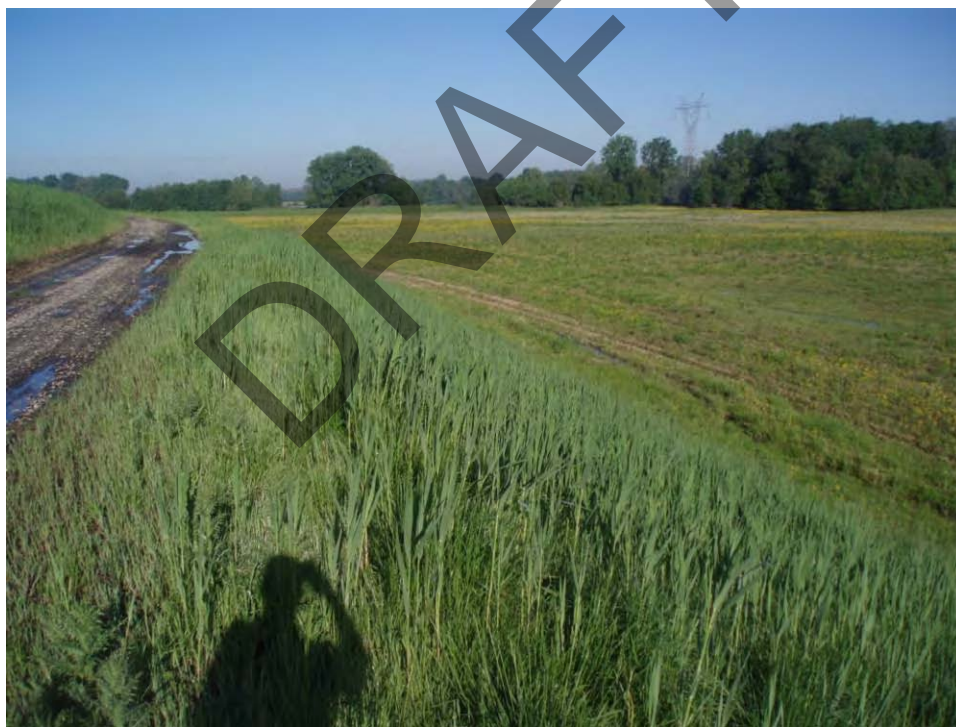
114. Pond C - Wes embankment bench, looking west.

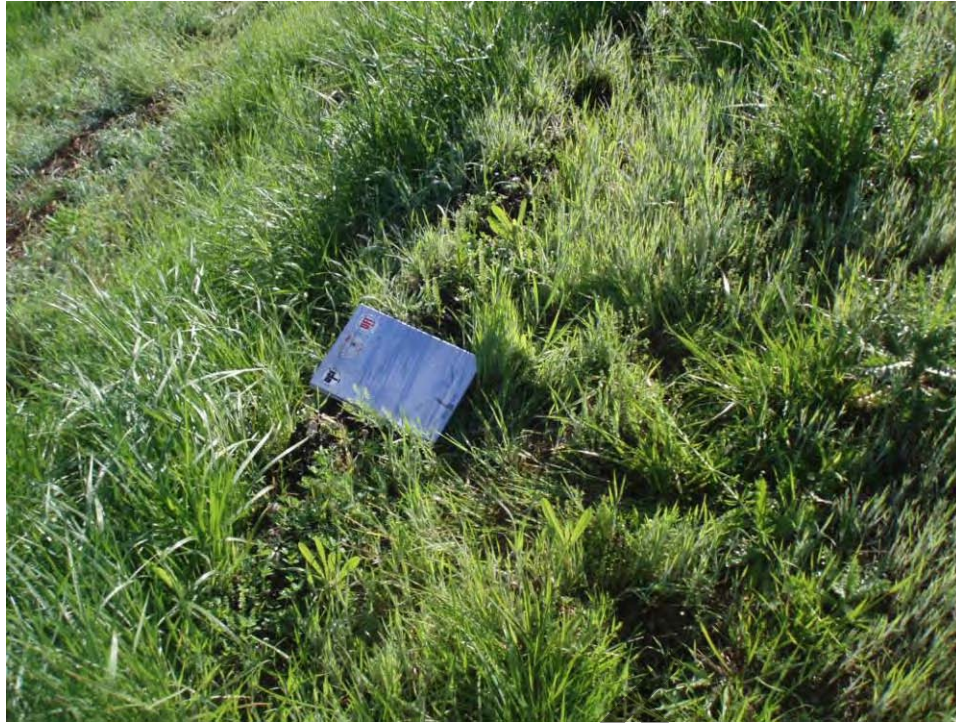
115. Pond C - West embankment lower exterior slope, looking at over-steepened area and tractor rutting at bench.

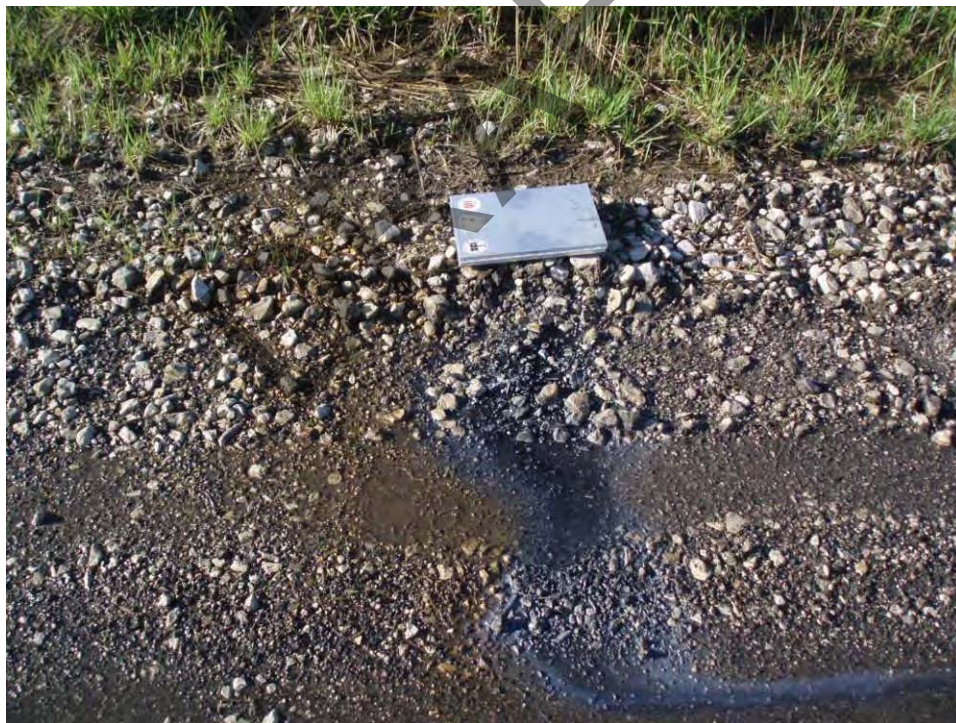
Seepage around perimeter of embankment at toe of vertical expansion from El. 440 to El. 452.
Sporadic white and black clouding and iron staining in seepage water.

116. Pond C - West embankment bench, looking at active seepage located at toe of upper exterior slope. Note the white and black sheen in the water.

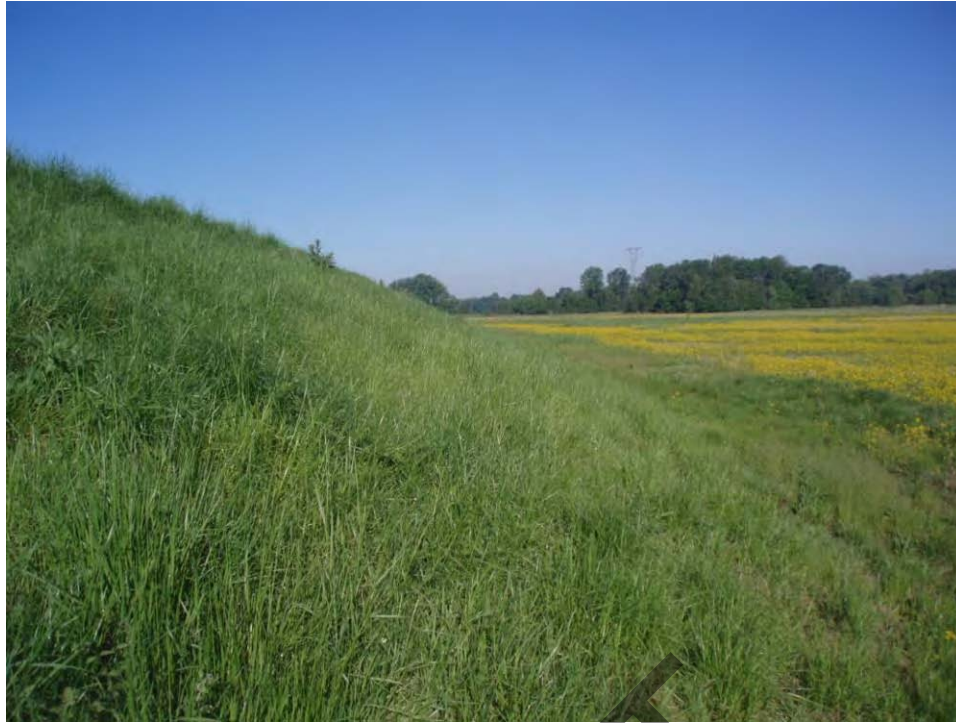
117. Pond C - West embankment lower exterior slope, looking west.

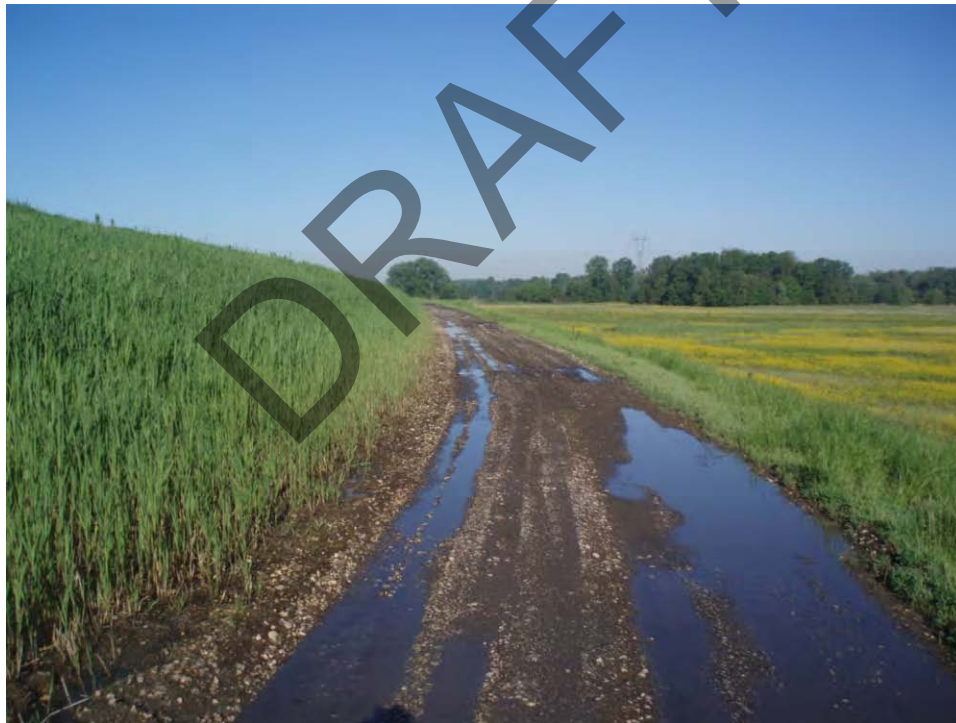
118. Pond C - West embankment bench, looking west.

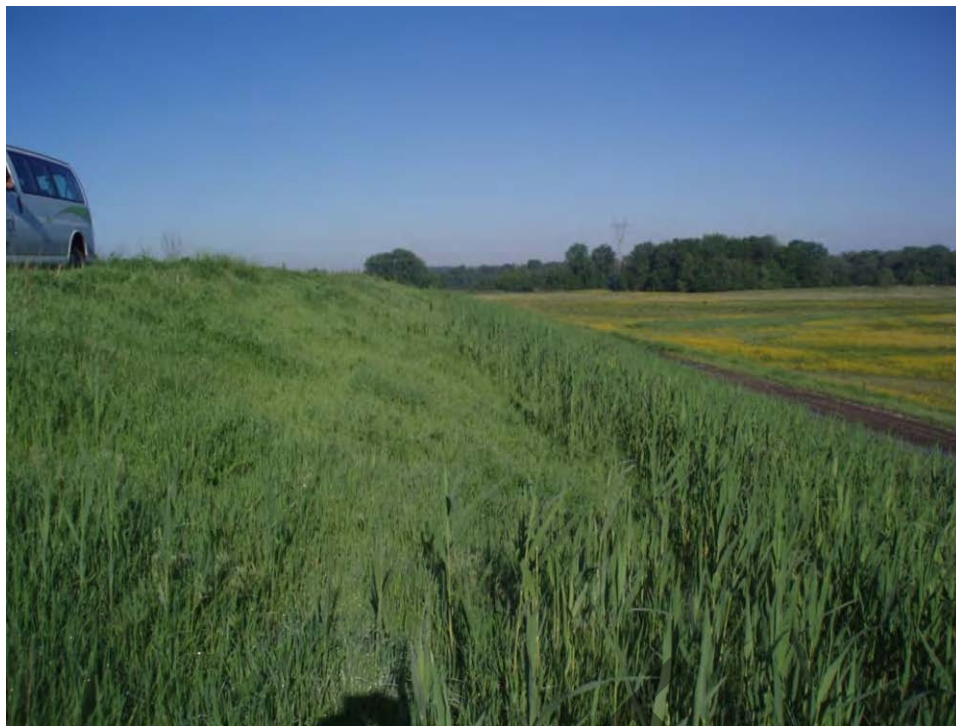
119. Pond C – West embankment upper exterior slope, looking west.

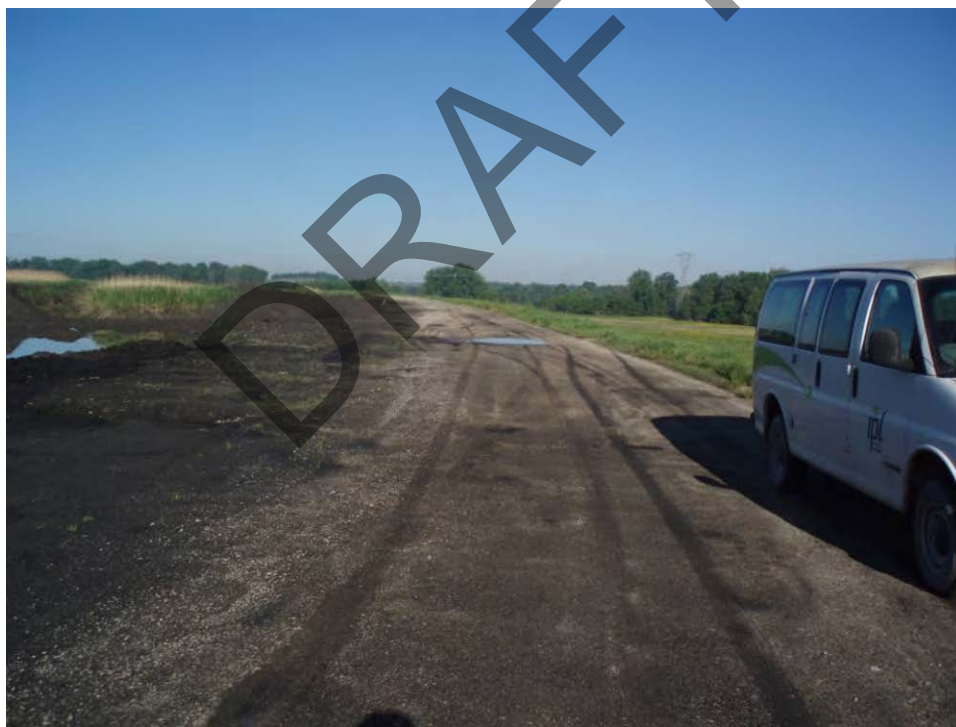
120. Pond C – West embankment crest, looking west.

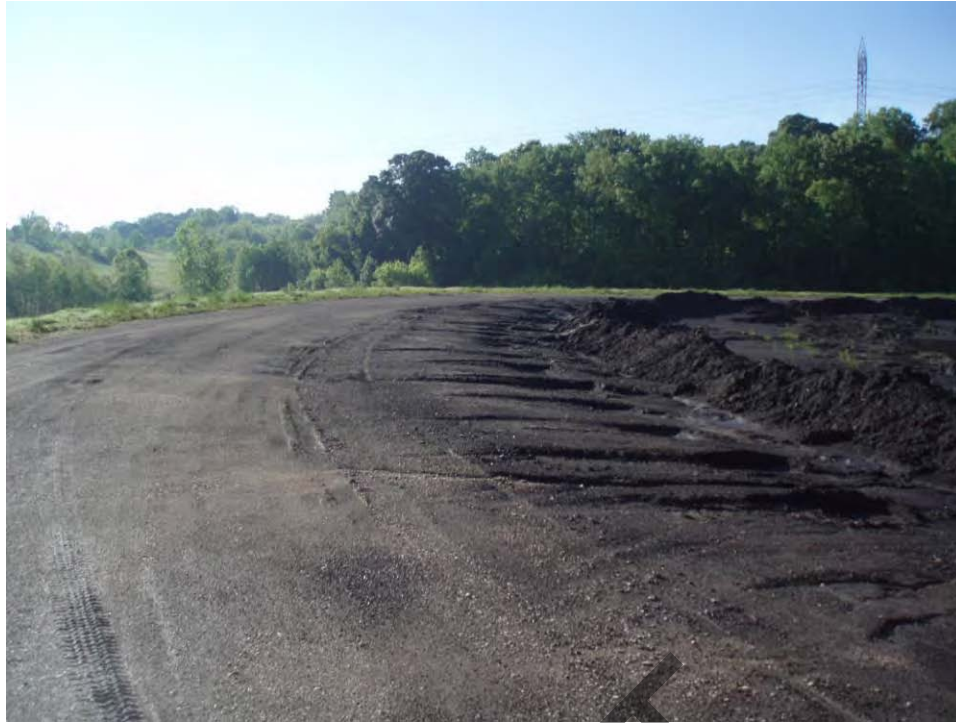
121. Pond C – North embankment crest, looking southeast.

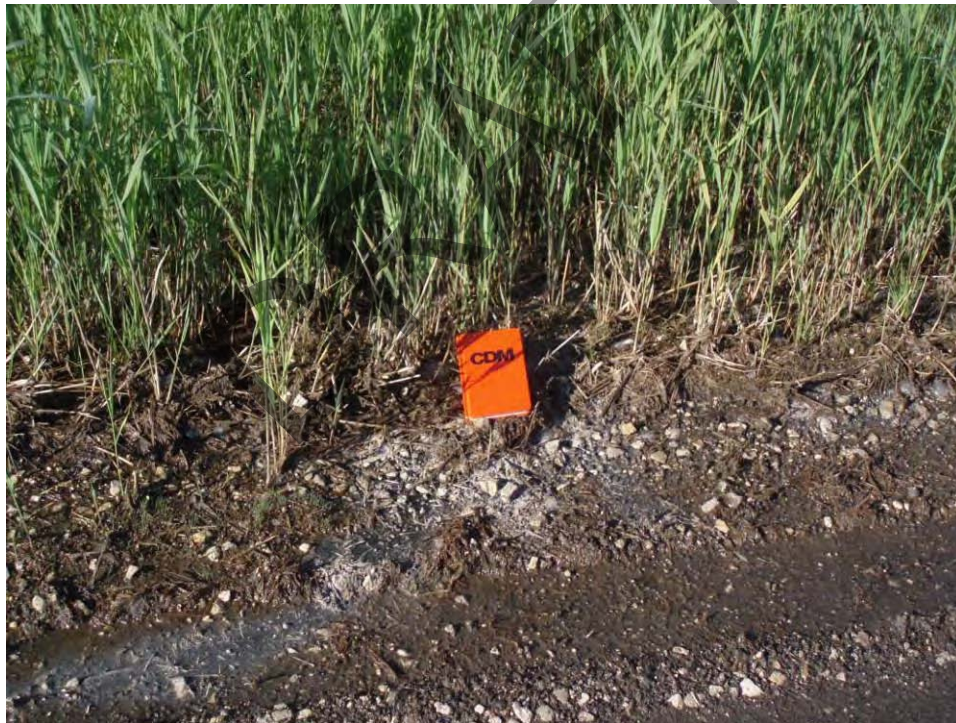
20. Outlet was obscured by thick vegetation.	
21. Seepage around perimeter of embankment at toe of vertical expansion from El. 440 to El. 452. Sporadic white and black clouding and iron staining in seepage water.

122. Pond C – North embankment bench, looking at active seepage located at toe of upper exterior slope. Note the white sheen in the water.

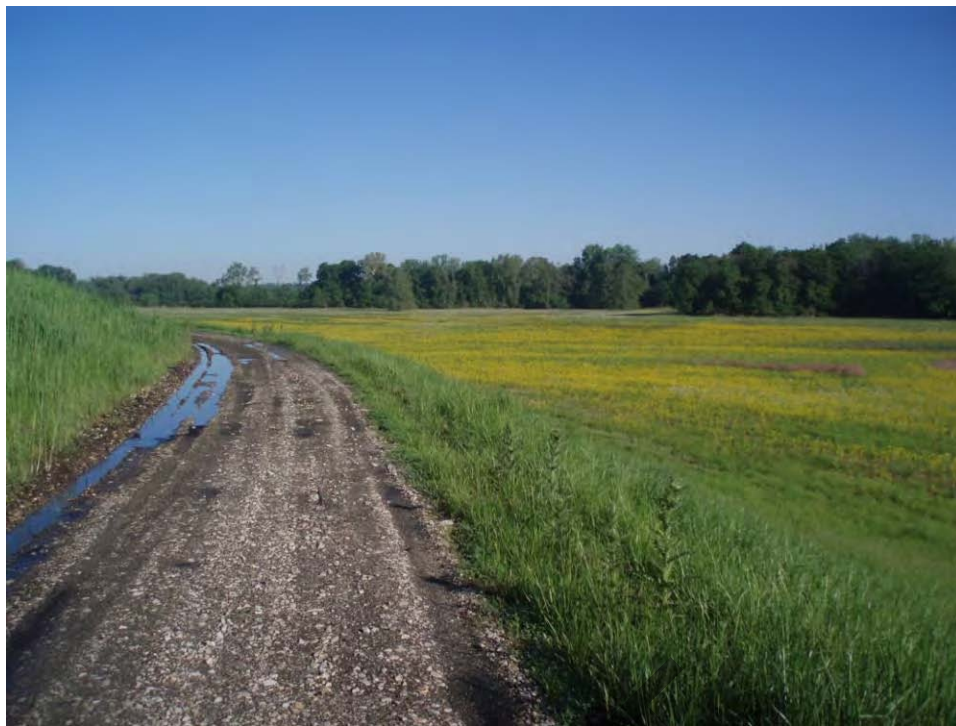
123. Pond C – North embankment bench, looking northwest.

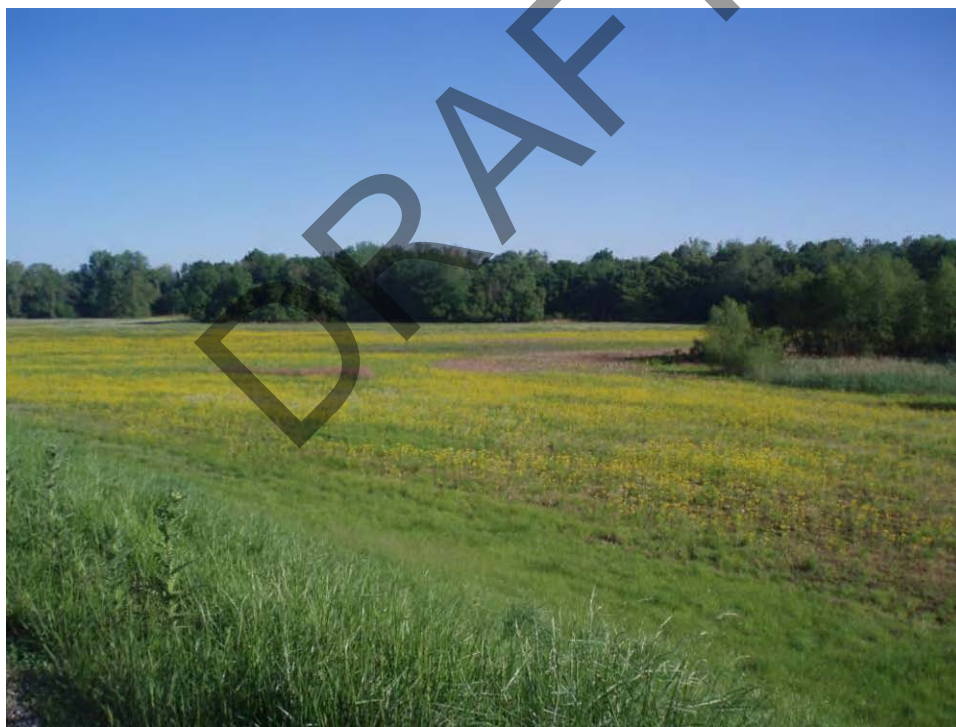
124. Pond C – North embankment, looking north at downstream area.

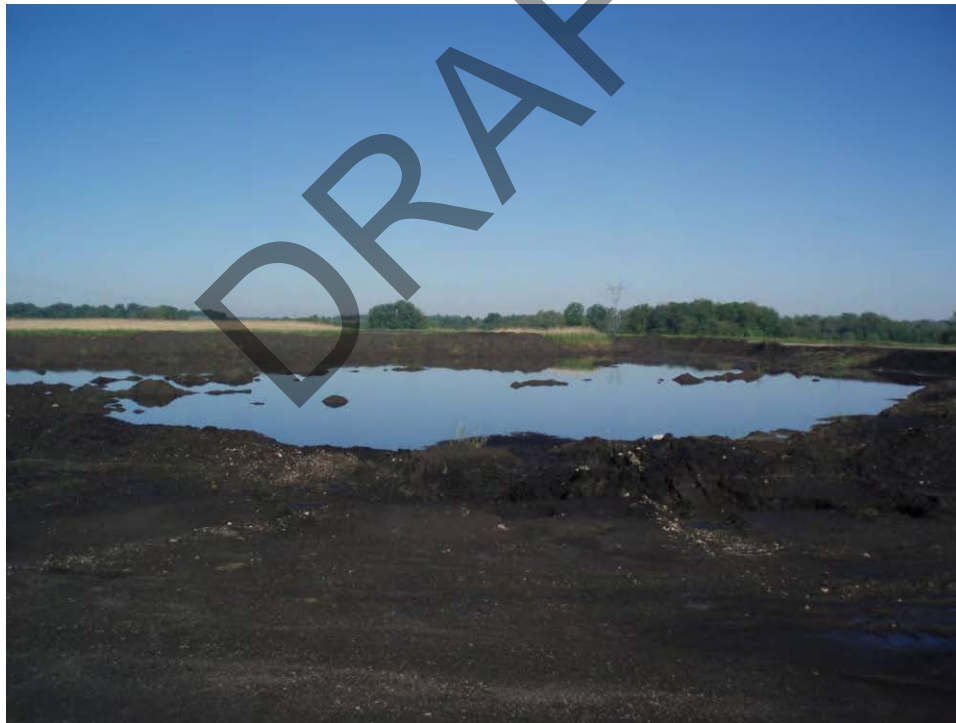
126. Overview of Pond C from northeast corner, looking northwest.

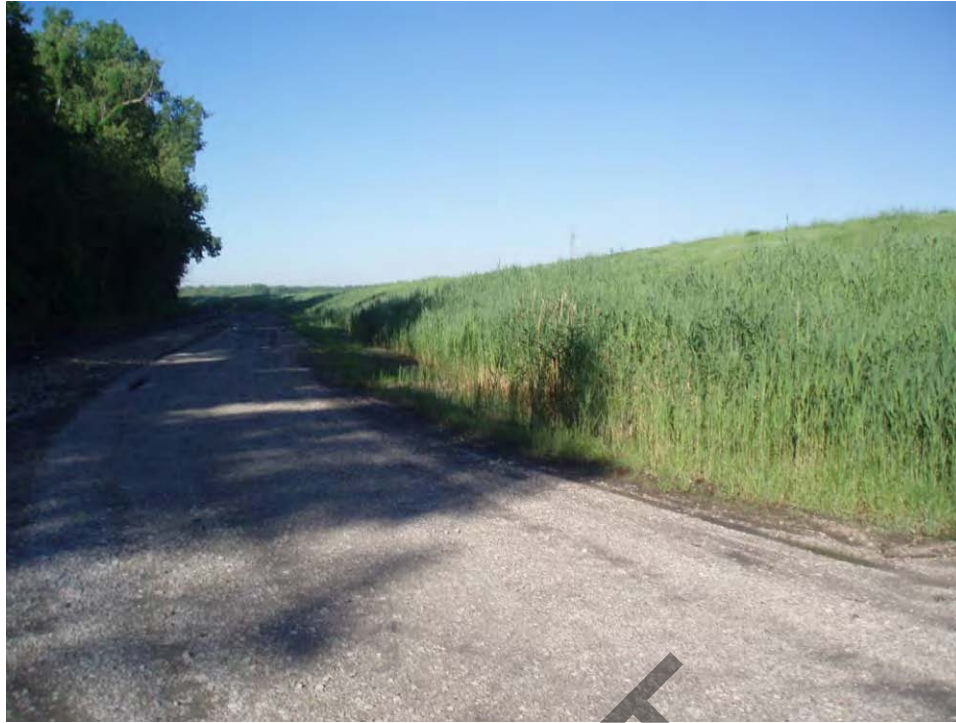
127. Pond C - East embankment exterior slope and drainage ditch, looking southwest. Note water level in drainage ditch approximately 1.5' below roadway and 5'-8' tall vegetation on lower portion of the slope extending from northern corner to access ramp. Slope at drainage ditch is over-steepened.

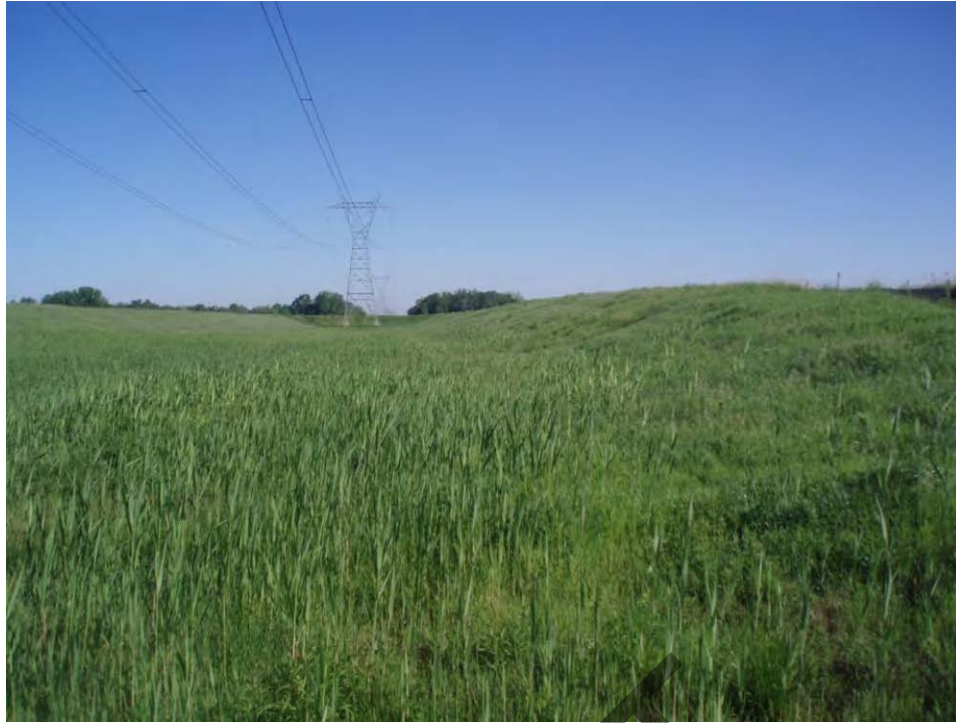
131. Overview of area between Pond B and Pond C, looking northwest. Note area between embankments is the top of the original impoundment.

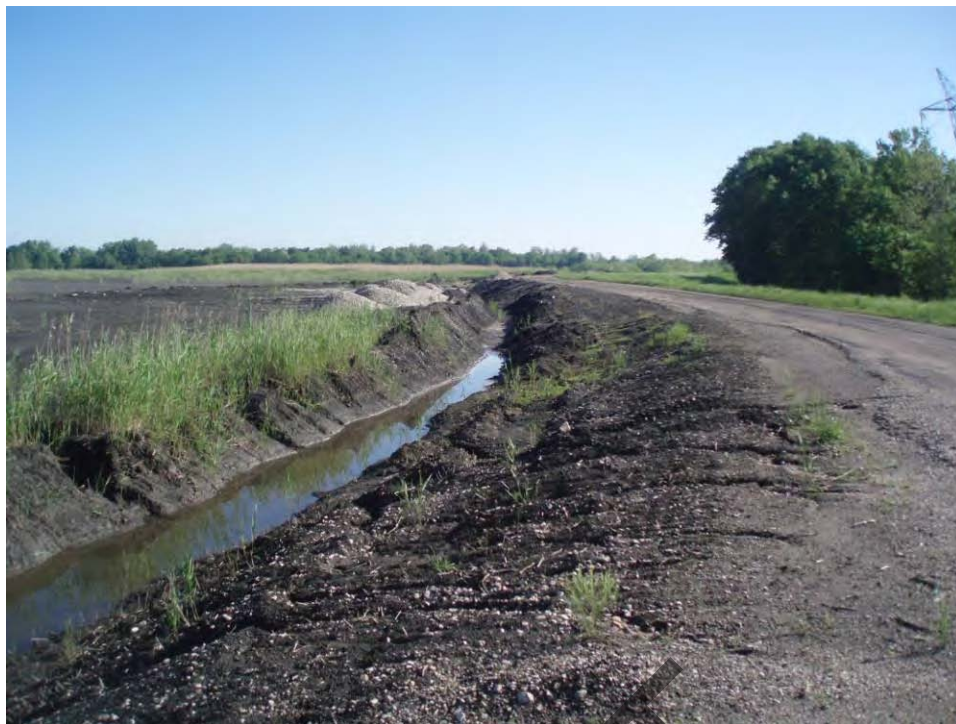
133. Pond C - East embankment interior slope, looking north at rim ditch to outlet structure.

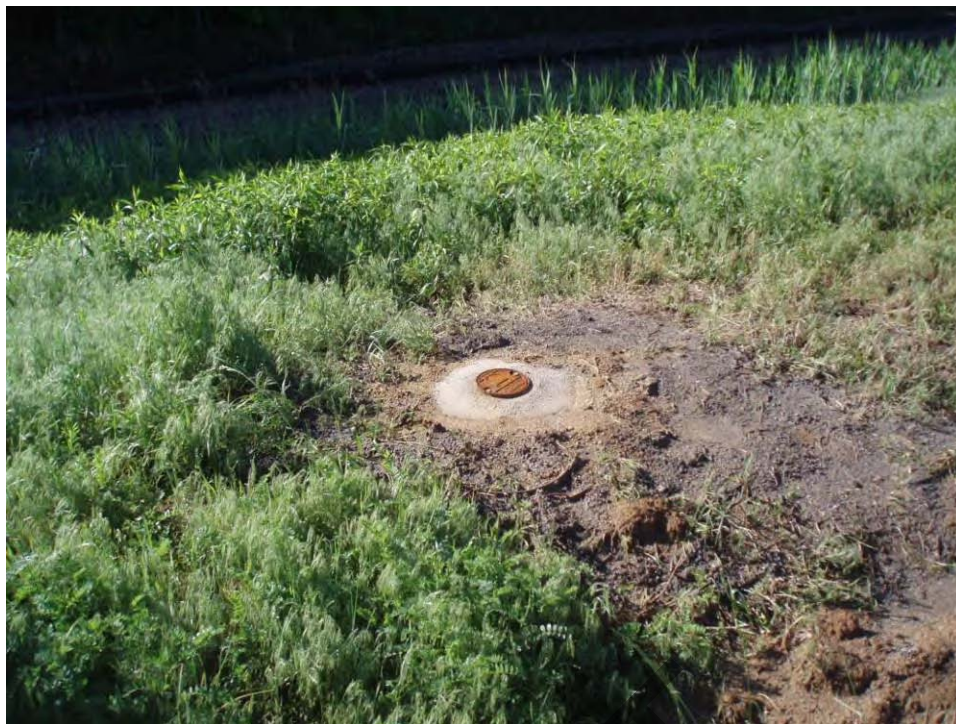
135. Pond C - East crest, looking at monitoring well installed by BT² on 4/23/10.

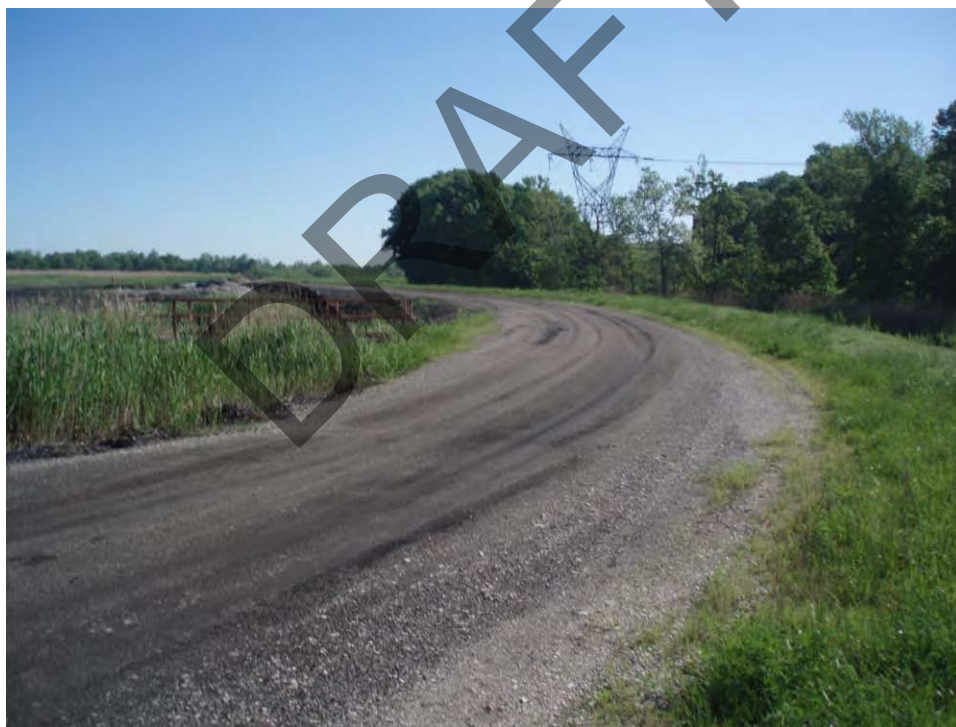
136. Pond C - East embankment crest, looking northeast.

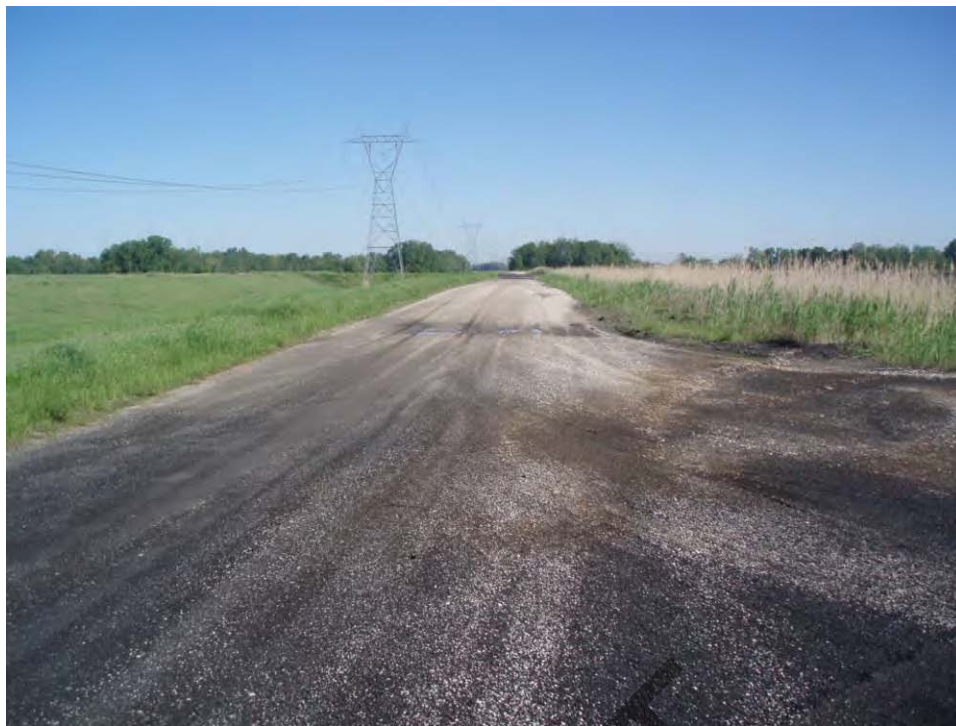
137. Pond C – South embankment crest, looking northwest.

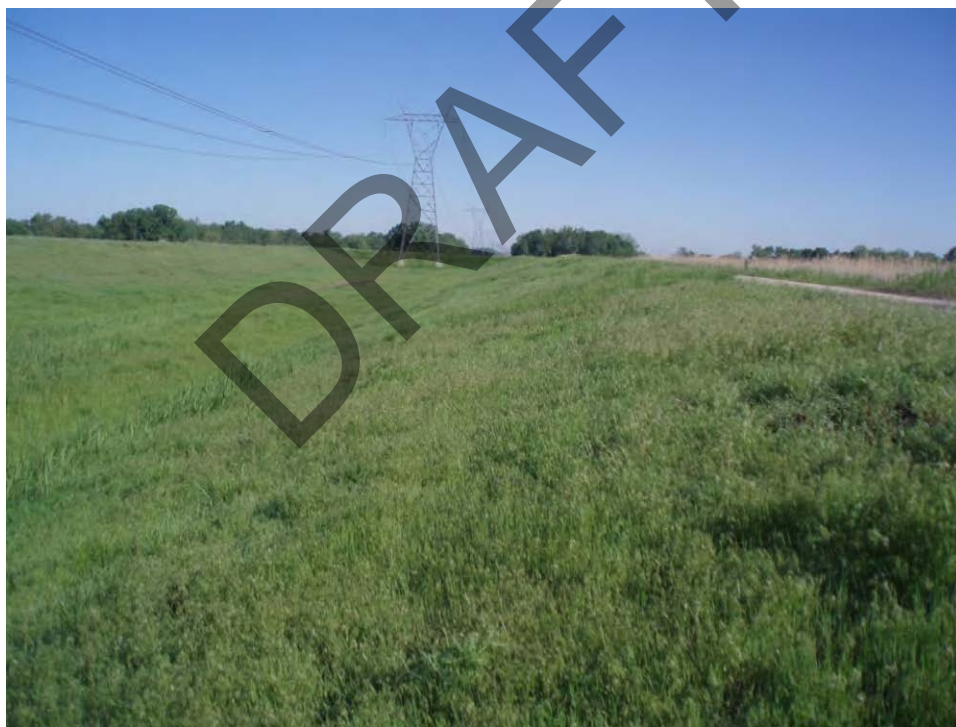
138. Pond C – South embankment exterior slope, looking northwest at area between Pond B and Pond C.

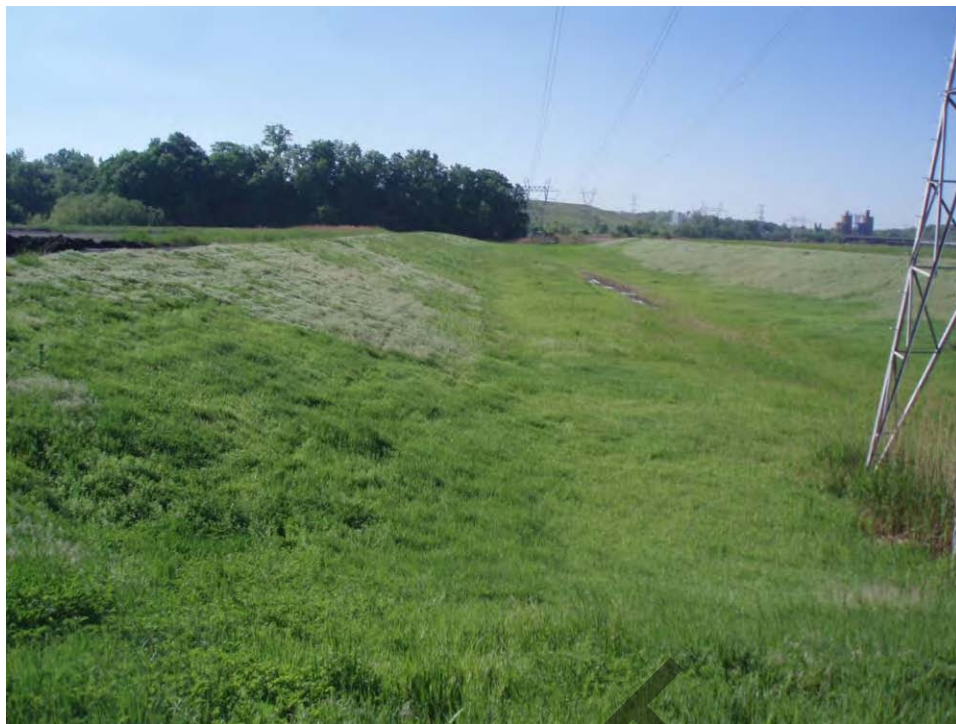
139. Pond C – South embankment exterior slope, looking southeast at area between Pond B and Pond C.

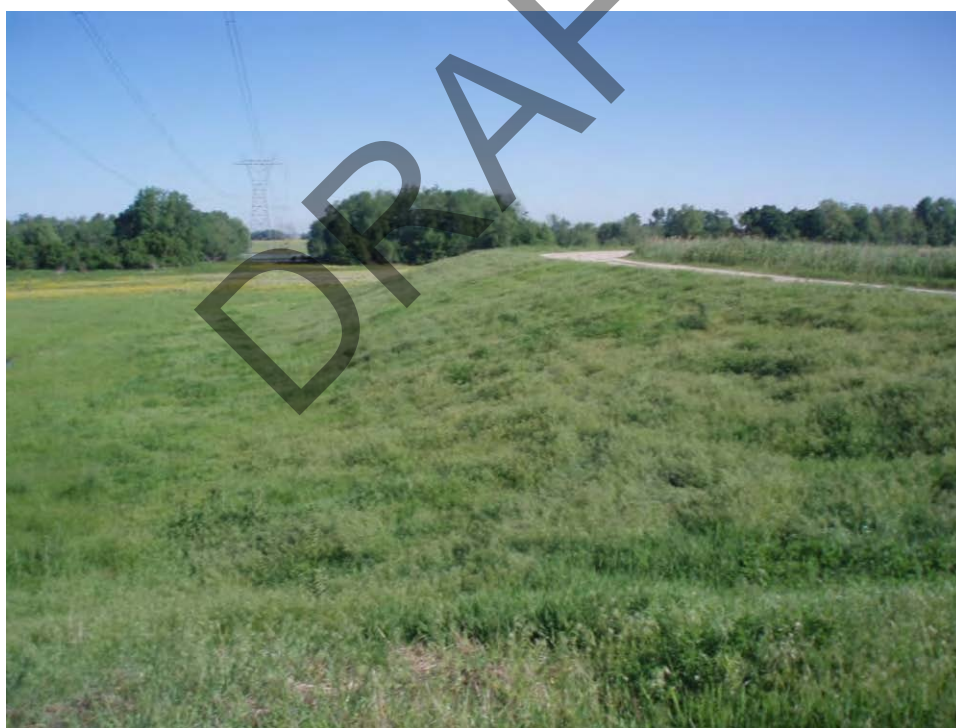
140. Pond C – South embankment exterior slope, looking northwest.

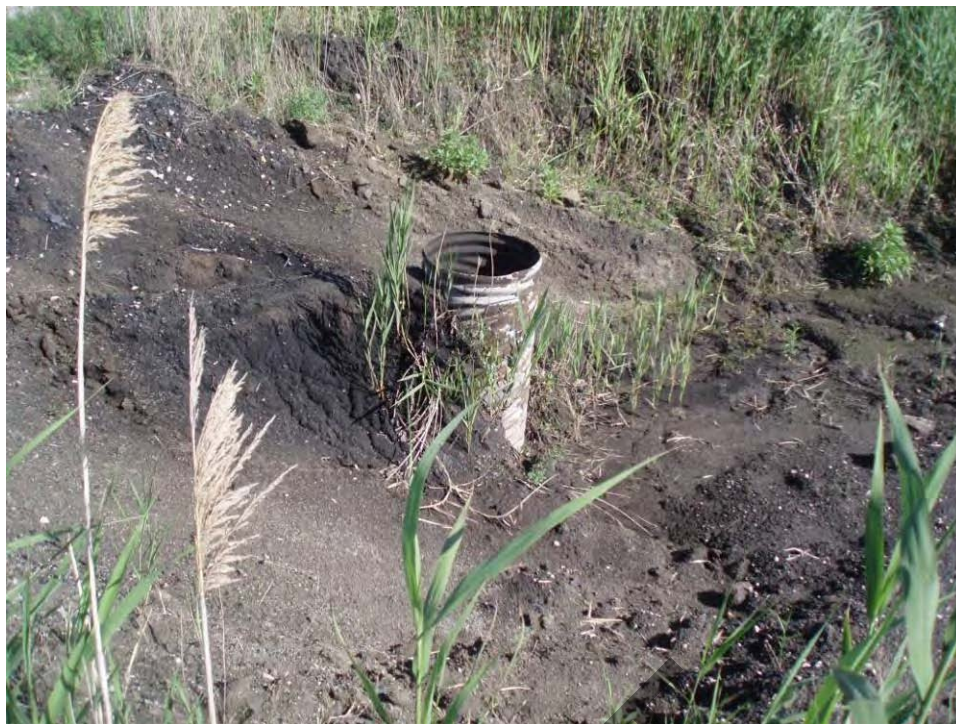
141. 24-inch-diameter CMP equalizer pipe from Pond C to Pond B. Note inlet has a T connection on the end of the pipe.

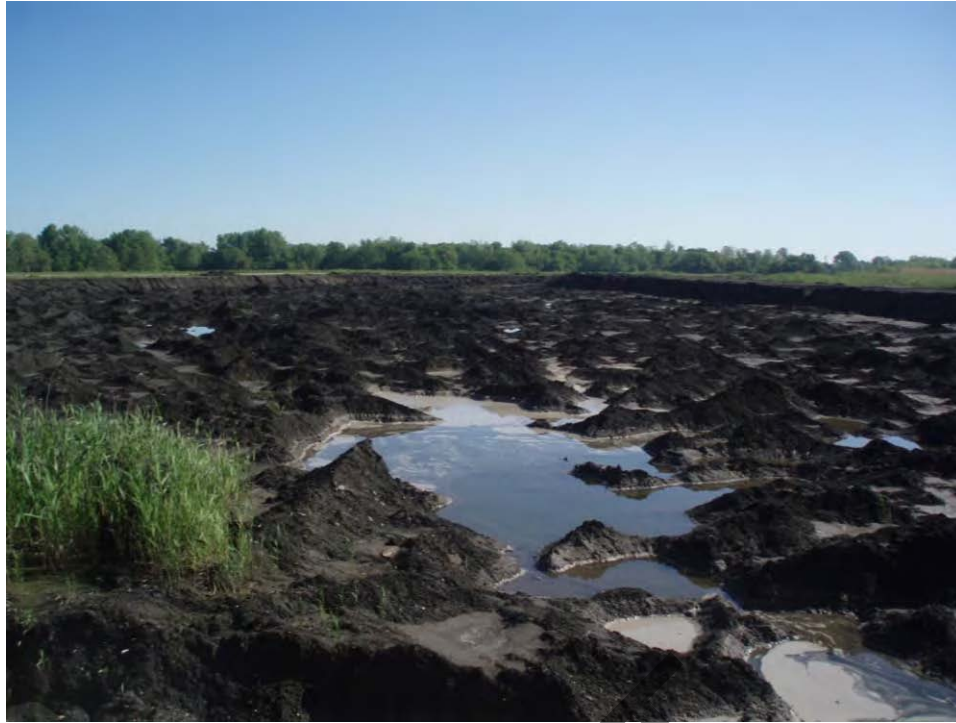
143. Overview of Pond C, looking northeast.

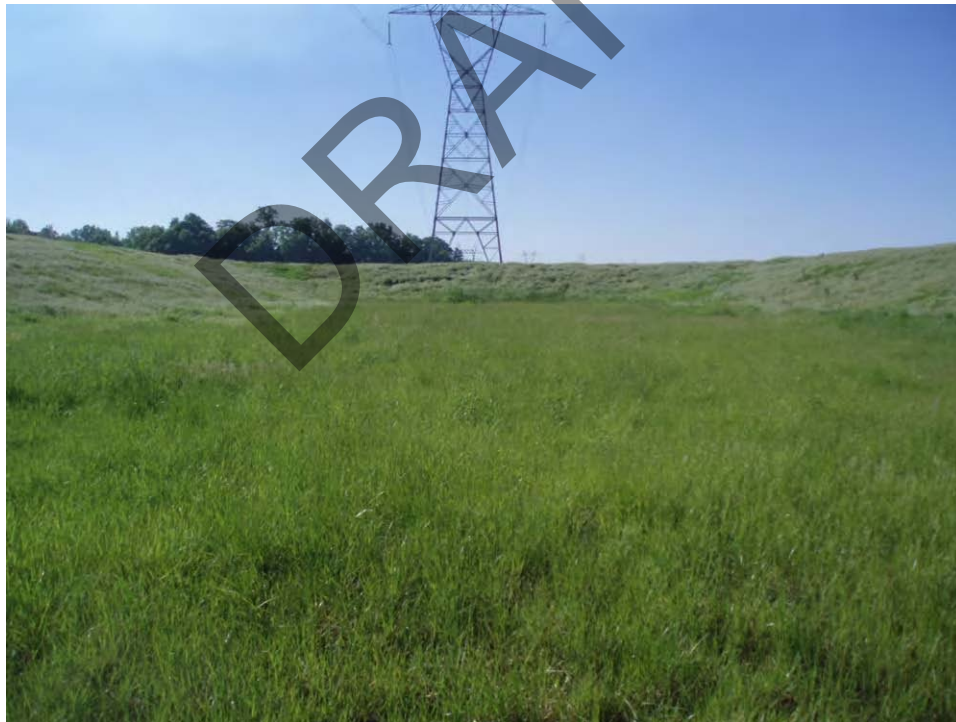
144. Low area between Pond B and Pond C, looking north at embankment between two impoundments. Note the equalizer pipe runs through the embankment.

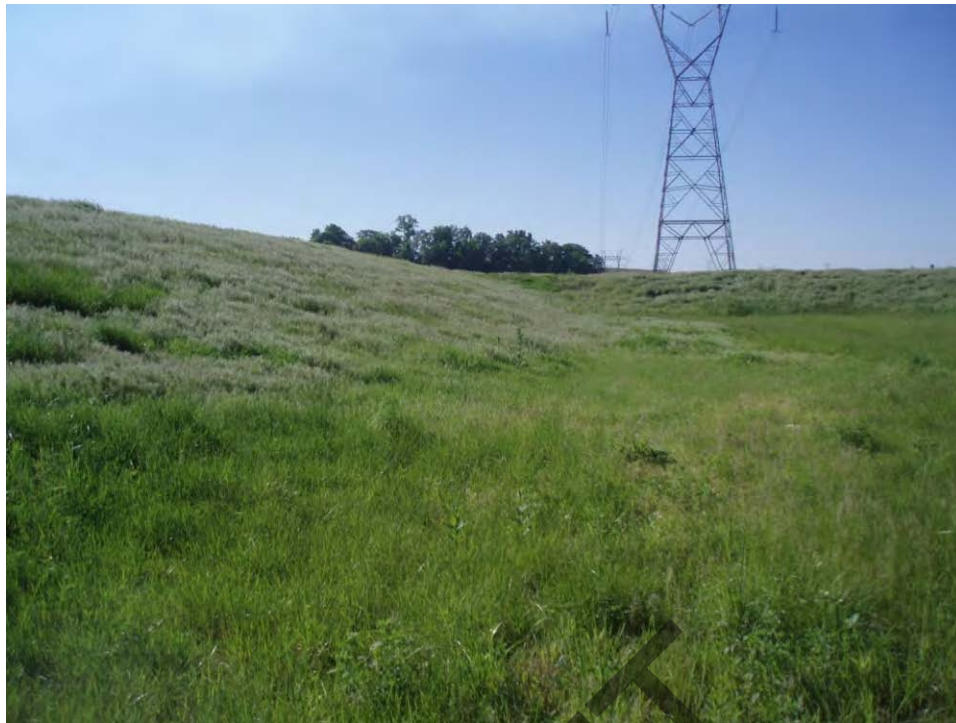
145. Pond C - South embankment exterior slope, looking southeast.
